PRIMARY RECORD

* Resource Name or #: 6232 Anthony Avenue

c. Address 6232 Anthony Ave City Garden Grove Zip 92845

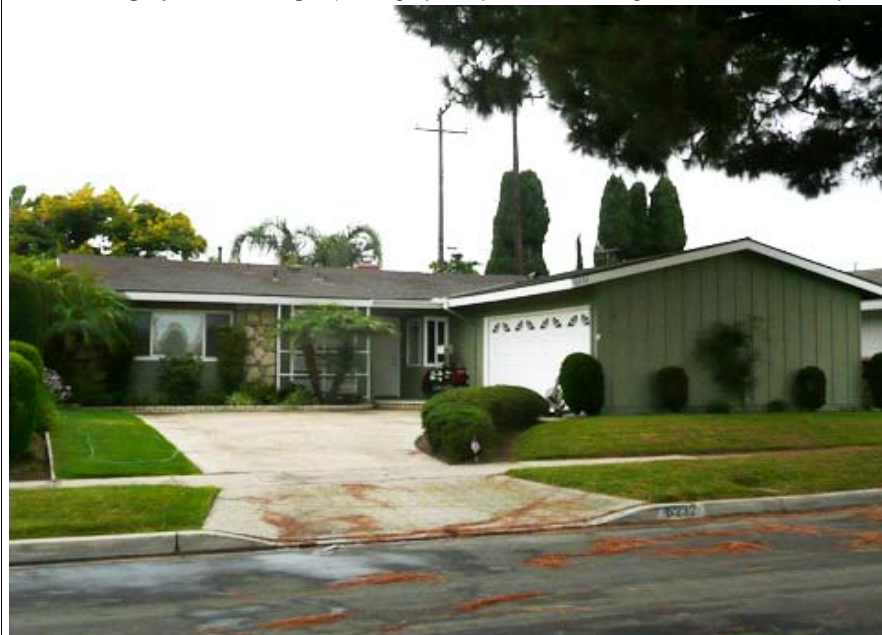
Facing south; 10/5/2010; Photo No.

* P3a. Description: (Describe resource and its major elements. Include design, materials, condition, alterations, size, setting, and boundaries.)
The one-story Ranch style building is 'L'-shaped in plan. The cross gabled roof, with boxed eaves, is clad in composition shingles. The exterior walls are clad in smooth textured stucco and vertical wood siding. A band of stone veneer accents the eastern bay of the primary (northern) façade. The windows have been replaced with vinyl sliding and sash units. The primary entrance is raised and recessed. A geometric trellis accents the primary entrance. Landscaping includes brick planters. The building does not meet the NRHP and CRHR eligibility criteria for the reasons identified on the district record prepared for this subdivision; therefore the building does not contribute to a historic district and is not individually eligible for listing in the NRHP and the CRHR.

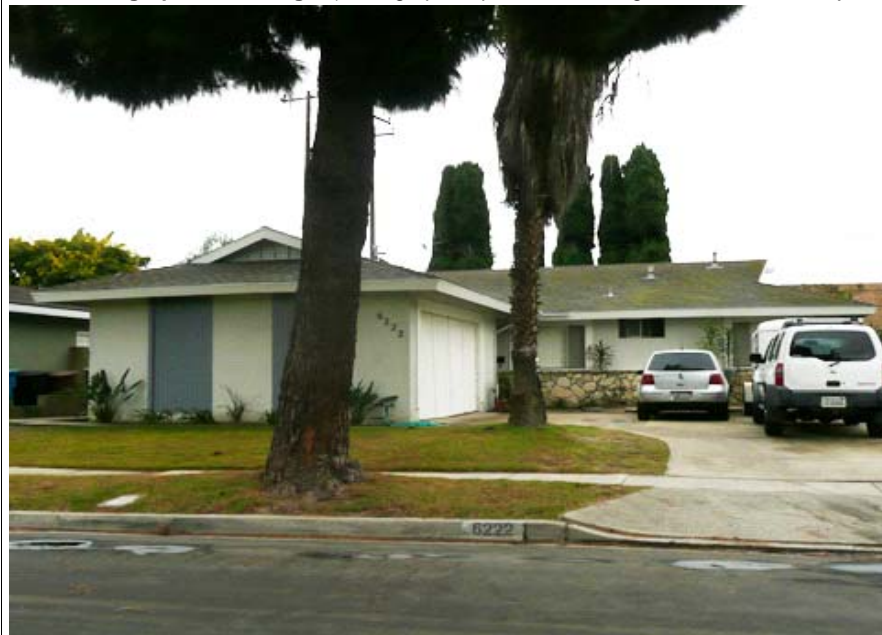
Facing south; 10/5/2010; Photo No.

* P3a. Description: (Describe resource and its major elements. Include design, materials, condition, alterations, size, setting, and boundaries.)
The one-story Ranch style building is 'L'-shaped in plan. The flared gable on hip roof, with flared and boxed eaves, is clad in composition shingles. The front-facing gable is accented with lattice-patterned false timbering, and the east-facing gable is accented with a false beam. The exterior walls are clad in smooth textured stucco. The northern façade of the attached two-car garage is accented with two bands of vertical wood siding, and the western bay of the primary (northern) façade is accented with stone veneer to the water line. The aluminum sliding windows appear to be original. The primary entrance is recessed and is not visible from the public right of way. The building does not meet the NRHP and CRHR eligibility criteria for the reasons identified on the district record prepared for this subdivision; therefore the building does not contribute to a historic district and is not individually eligible for listing in the NRHP and the CRHR.

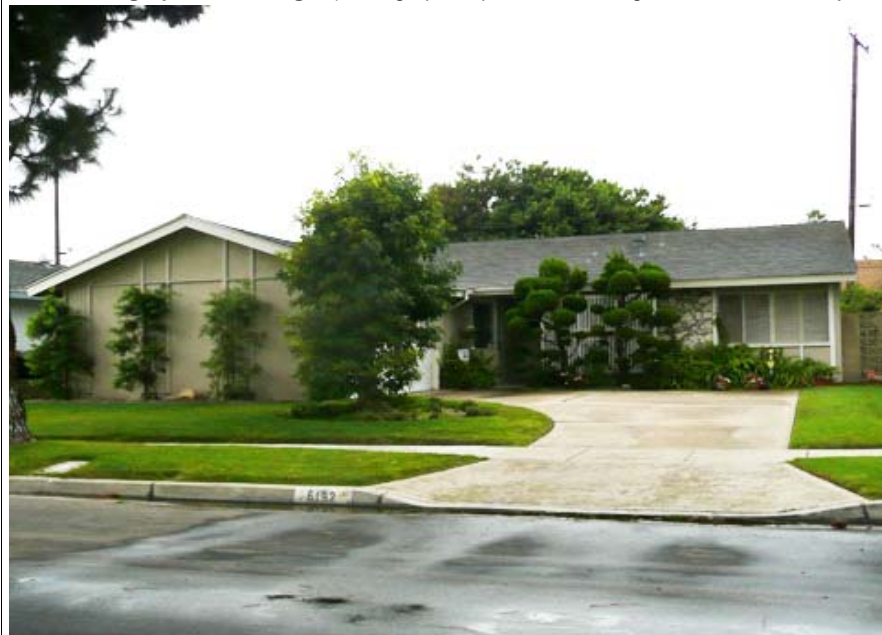
Facing south; 10/5/2010; Photo No.

* P3a. Description: (Describe resource and its major elements. Include design, materials, condition, alterations, size, setting, and boundaries.)
The one-story Ranch style building is 'L'-shaped in plan. The cross gabled roof, with boxed eaves, is clad in composition shingles. The exterior walls are clad in smooth textured stucco with false timbering. A band of stone veneer accents the western bay of the primary (northern) façade. The aluminum sliding windows appear to be original, and are accented with wood surrounds. The primary entrance is recessed, and accessed via a cast concrete porch. A decorative trellis accents the primary entrance. The building does not meet the NRHP and CRHR eligibility criteria for the reasons identified on the district record prepared for this subdivision; therefore the building does not contribute to a historic district and is not individually eligible for listing in the NRHP and the CRHR.

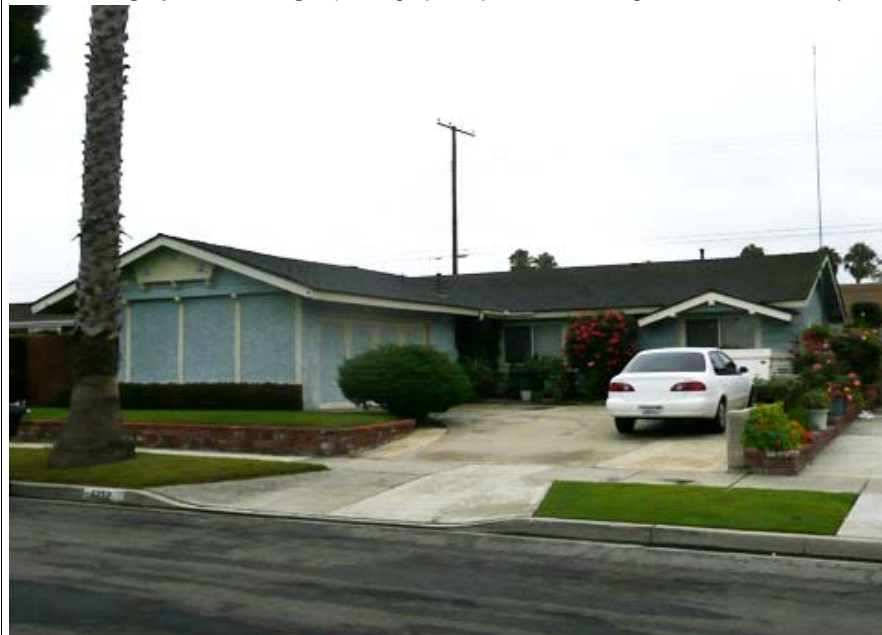
Facing south; 10/5/2010; Photo No.

* P3a. Description: (Describe resource and its major elements. Include design, materials, condition, alterations, size, setting, and boundaries.)
The one-story Ranch style building is 'L'-shaped in plan. The cross gabled roof, with boxed eaves, is clad in composition shingles. The easterly front-facing gable is accented with a dove-cote, corbels, and horizontal wood siding. The westerly front-facing gable is accented with false beams. The exterior walls are clad in rough textured stucco, which appears to be an alteration, and false timbering, and horizontal wood siding. The aluminum sliding windows appear to be original, and are accented with wood surrounds. The primary entrance is recessed, and is not visible from the public right of way. The building does not meet the NRHP and CRHR eligibility criteria for the reasons identified on the district record prepared for this subdivision; therefore the building does not contribute to a historic district and is not individually eligible for listing in the NRHP and the CRHR.

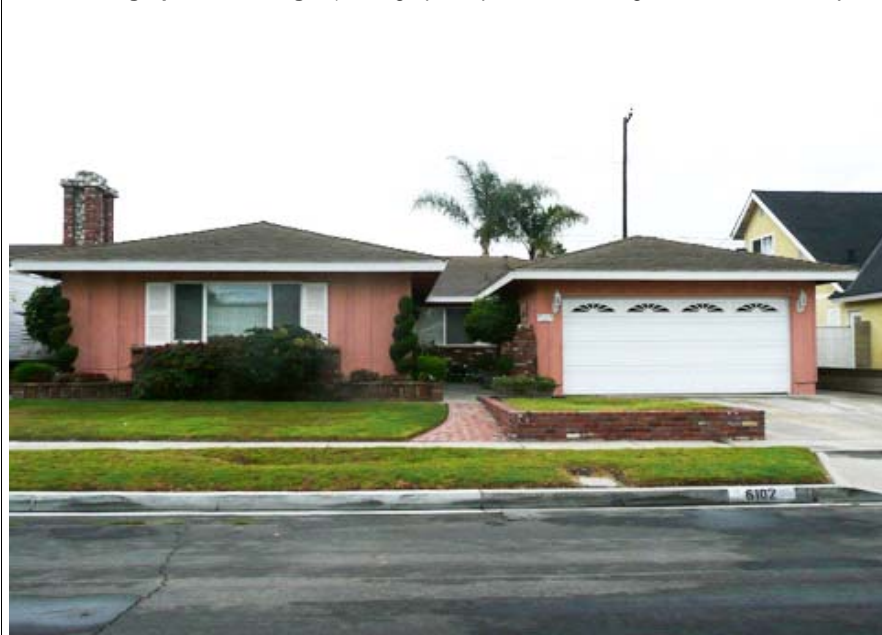
Facing south, 10/5/2010; Photo No.

* P3a. Description: (Describe resource and its major elements. Include design, materials, condition, alterations, size, setting, and boundaries.)
The one-story Ranch style building is 'U'-shaped in plan. The cross hipped roof, with boxed eaves, is clad in composition shingles. The brick and stone chimney located on the eastern façade appears to be an alteration as it is dissimilar to other chimneys in the neighborhood. The exterior walls are clad in vertical wood siding, and the recessed central bay is accented with brick veneer to the water line. The windows have been replaced with vinyl sliding and fixed-pane units, and are accented with shutters. The primary entrance is recessed and is not visible from the public right of way. Landscaping includes brick planters and a brick retaining wall. The building does not meet the NRHP and CRHR eligibility criteria for the reasons identified on the district record prepared for this subdivision; therefore the building does not contribute to a historic district and is not individually eligible for listing in the NRHP and the CRHR.

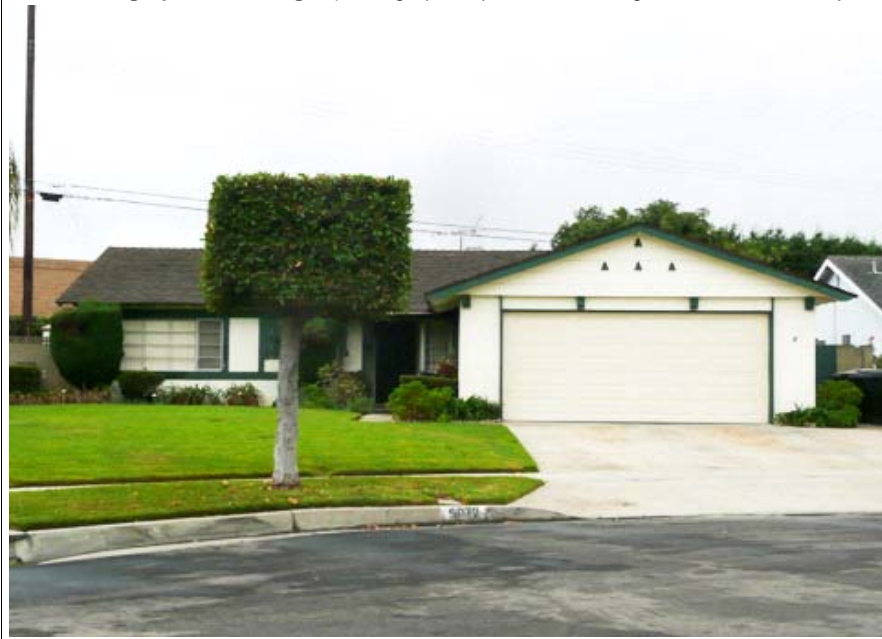
Facing south; 10/5/2010; Photo No.

* P3a. Description: (Describe resource and its major elements. Include design, materials, condition, alterations, size, setting, and boundaries.)
The one-story Ranch style building is 'L'-shaped in plan. The cross gabled roof, with exposed rafter tails, is clad in composition shingles. The front-facing gable is accented with barge board, a doveote, corbels, and horizontal wood siding. The exterior walls are clad in smooth textured stucco, and the eastern bay of the primary (northern) façade is accented with a band board at the water line and false timbering. The multi-light wood casement and fixed-pane windows appear to be original, and are accented with wood surrounds. The primary entrance is recessed, raised, and accessed via a cast concrete porch. The building does not meet the NRHP and CRHR eligibility criteria for the reasons identified on the district record prepared for this subdivision; therefore the building does not contribute to a historic district and is not individually eligible for listing in the NRHP and the CRHR.

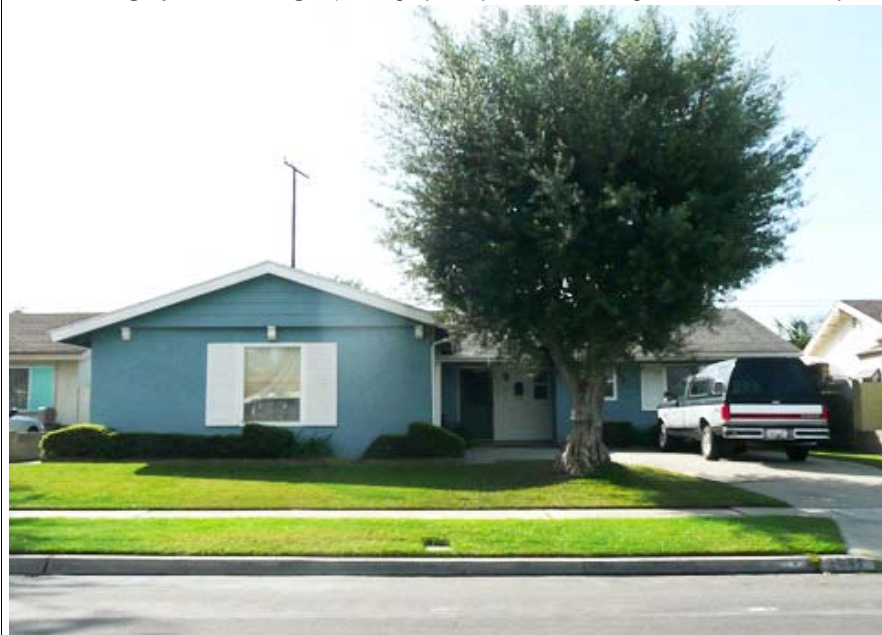
Facing south; 10/7/2010; Photo No.

* P3a. Description: (Describe resource and its major elements. Include design, materials, condition, alterations, size, setting, and boundaries.)
The one-story Ranch style building is 'L'-shaped in plan. The cross gabled roof, with boxed eaves, is clad in composition shingles. The front-facing gable is accented with corbels and horizontal wood siding. The exterior walls are clad in smooth textured stucco. The windows have been replaced with vinyl sash and fixed-pane units, and several are accented with shutters. The primary entrance is raised, recessed, and accessed via a cast concrete porch. The primary entry porch area is accented with vertical wood siding. The building does not meet the NRHP and CRHR eligibility criteria for the reasons identified on the district record prepared for this subdivision; therefore the building does not contribute to a historic district and is not individually eligible for listing in the NRHP and the CRHR.

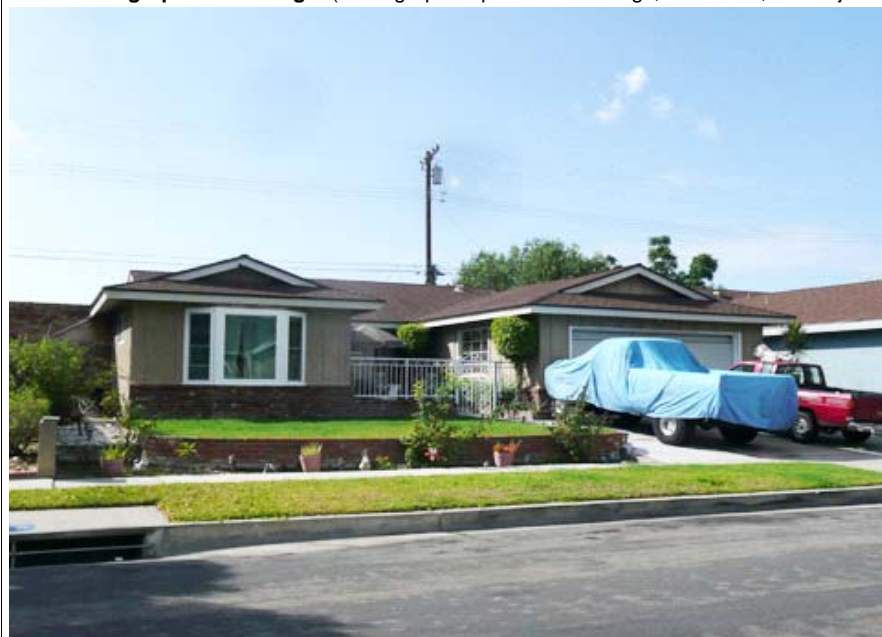
Facing south; 10/7/2010; Photo No.

* P3a. Description: (Describe resource and its major elements. Include design, materials, condition, alterations, size, setting, and boundaries.)
The one-story Ranch style building is 'U'-shaped in plan. The cross gable on hip roof, with boxed eaves, is clad in composition shingles. The front-facing gables are accented with board and batten siding. The exterior walls are clad in vertical wood siding with brick veneer to the water line. The eastern bay of the primary (northern) façade is accented with a canted bay. Most of the windows have been replaced with vinyl casement, fixed-pane and sash units. The multi-light wood fixed-pane window located on the eastern façade of the attached two-car garage appears to be original. The primary entrance is recessed and is not visible from the public right of way. Landscaping includes brick planters, and a brick retaining wall. The building does not meet the NRHP and CRHR eligibility criteria for the reasons identified on the district record prepared for this subdivision; therefore the building does not contribute to a historic district and is not individually eligible for listing in the NRHP and the CRHR.

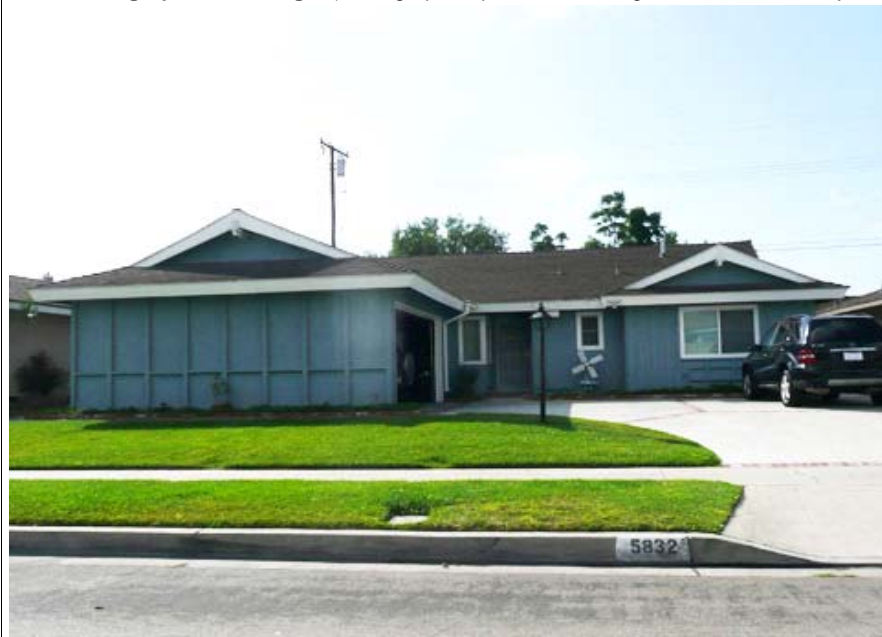
Facing south; 10/7/2010; Photo No.

* P3a. Description: (Describe resource and its major elements. Include design, materials, condition, alterations, size, setting, and boundaries.)
The one-story Ranch style building is 'L'-shaped in plan. The cross flared gable on hip roof, with flared and boxed eaves, is clad in composition shingles. The front-facing gables are accented with tapered barge board and false beams. The exterior walls are clad in smooth textured stucco and vertical wood siding. The northern façade of the attached two-car garage is accented with false timbering. The windows were replaced with vinyl sliding and sash units. The westernmost window on the primary (northern) façade is accented with a geometric spandrel panel. The primary entrance is raised and recessed. The building does not meet the NRHP and CRHR eligibility criteria for the reasons identified on the district record prepared for this subdivision; therefore the building does not contribute to a historic district and is not individually eligible for listing in the NRHP and the CRHR.

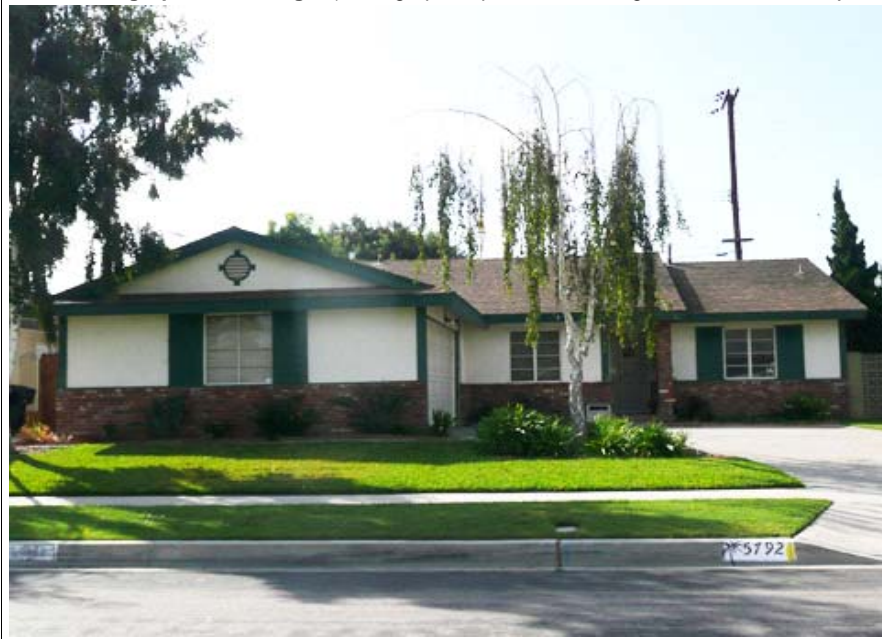
Facing south; 10/7/2010; Photo No.

* P3a. Description: (Describe resource and its major elements. Include design, materials, condition, alterations, size, setting, and boundaries.)
The one-story Ranch style building is generally 'L'-shaped in plan. The cross gabled roof, with boxed eaves, is clad in composition shingles. The front-facing gable is accented with Colonial Revival-style vent. The exterior walls are clad in smooth textured stucco with corner boards and brick veneer to the water line. The multi-light metal casement windows appear to be original, and are accented with shutters. The primary entrance is raised, recessed, and accessed via a brick veneer-clad porch. The overhanging roof which shelters the primary entry porch is supported by a brick pier. The building does not meet the NRHP and CRHR eligibility criteria for the reasons identified on the district record prepared for this subdivision; therefore the building does not contribute to a historic district and is not individually eligible for listing in the NRHP and the CRHR.

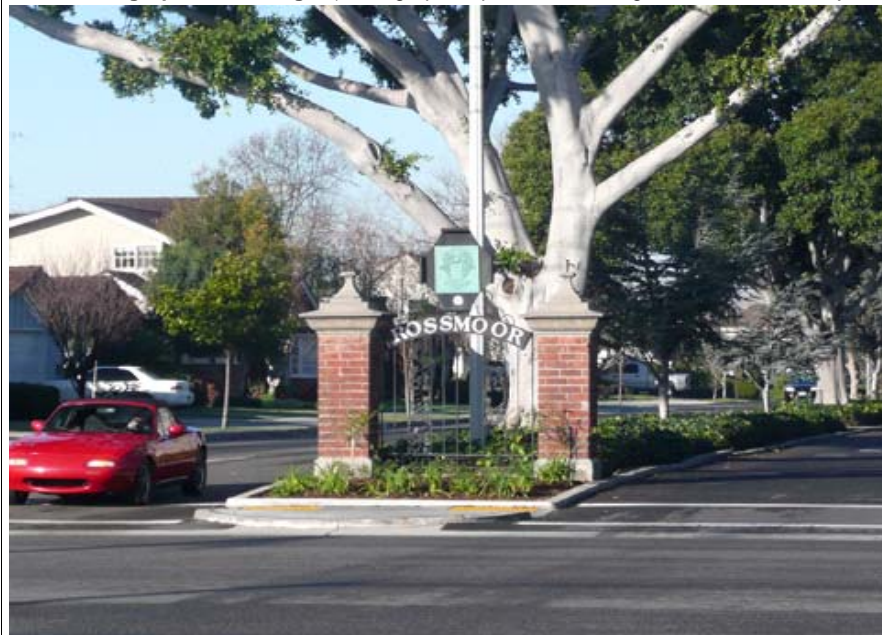
* P3a. Description: (Describe resource and its major elements. Include design, materials, condition, alterations, size, setting, and boundaries.)
Of the 185 parcels of Rossmoor located within the APE, 76 possessed sufficient integrity to warrant further investigation, which resulted in the district retaining 41% integrity. Because of the percentage of alterations, the district does not retain sufficient integrity to be considered eligible for listing in the National Register of Historic Places or the California Register of Historical Resources.

P5b. Description of Photo: (View, date, etc.)
View of an entry into the neighborhood.

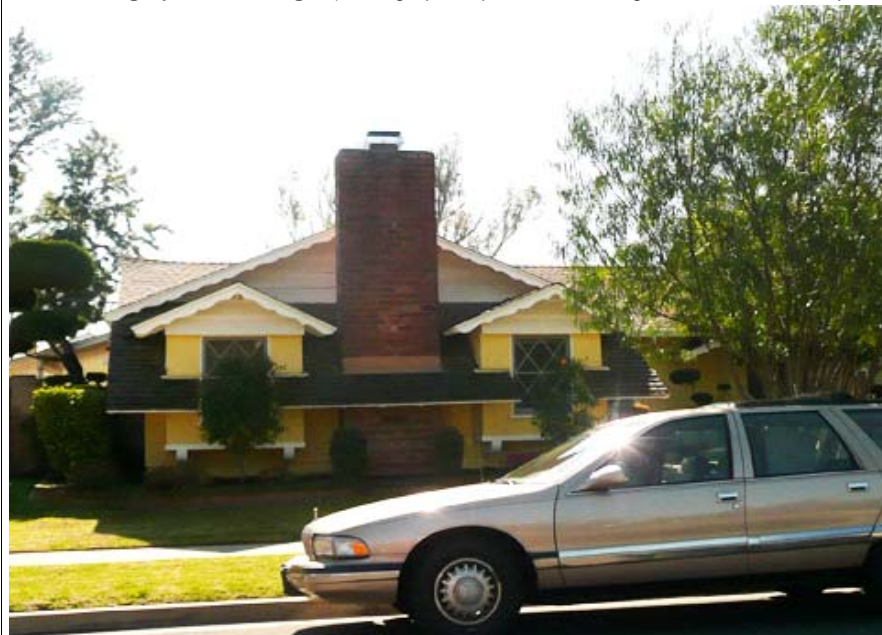
Facing southeast; 2/10/2010; Photo No.

* P3a. Description: (Describe resource and its major elements. Include design, materials, condition, alterations, size, setting, and boundaries.)
The one-story Storybook Ranch style building is 'L'-shaped in plan. The cross gabled roof, with boxed eaves, is clad in composition shingles. The front facing gables are accented with wavy-edge horizontal wood siding and the eaves are accented with scalloped barge board. The exterior walls are clad in smooth textured stucco. The diamond-paned sash windows appear to be original. The windows located in the eastern bay of the primary (northern) façade are located within projecting bays accented with corbels which flank a centrally located brick chimney. The primary entrance is at grade and recessed. Landscaping includes topiaries and brick planters. The building does not meet the NRHP and CRHR eligibility criteria for the reasons identified on the district record prepared for this subdivision; therefore the building does not contribute to a historic district and is not individually eligible for listing in the NRHP and the CRHR.

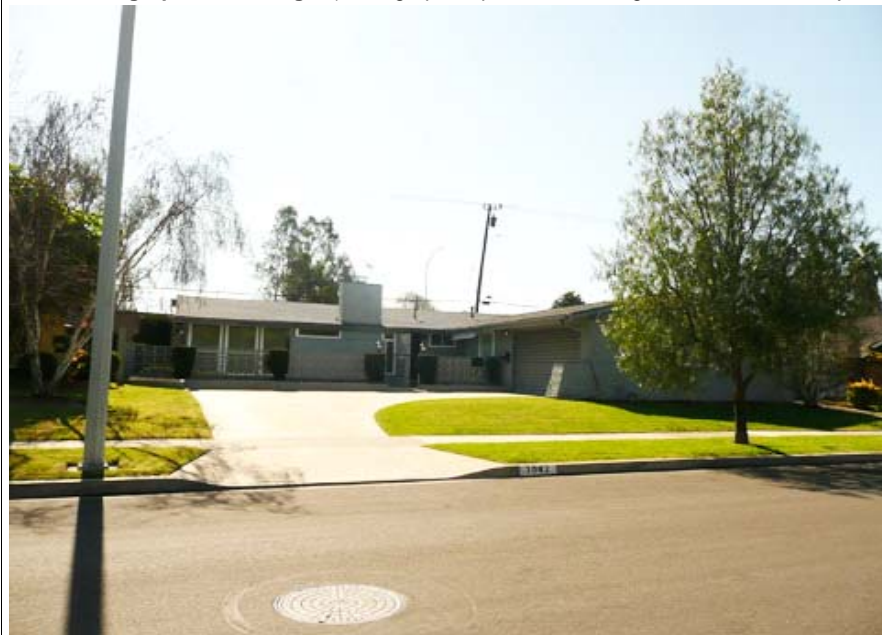
Facing north; 2/10/2010; Photo No.

* P3a. Description: (Describe resource and its major elements. Include design, materials, condition, alterations, size, setting, and boundaries.)
The one-story Ranch style building is 'L'-shaped in plan. The cross gabled roof is clad in composition shingles. A large brick chimney is prominently located on the western bay of the primary (southern) façade. The exterior walls are clad in smooth textured stucco. The northern façade of the attached two-car garage is accented with brick veneer to the water line which extends beyond the building to create a battered wall. The casement and fixed-pane windows were replaced with vinyl units at an unknown date. The primary entrance is recessed, and a brick wall extends to partially enclose the primary entry porch. A concrete screening block wall creates a private courtyard.

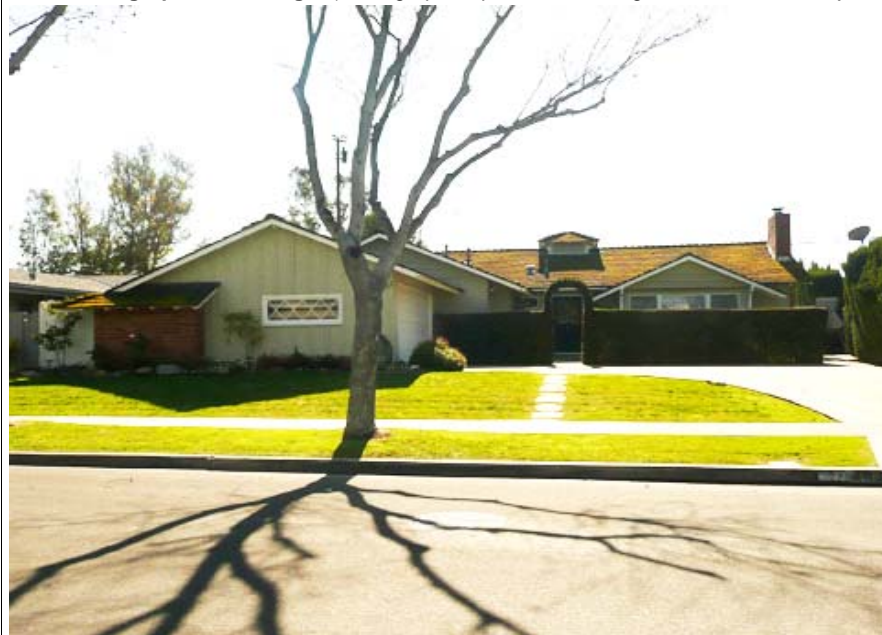
Facing southeast; 2/10/2010; Photo No.
P1030827.jpg

* P3a. Description: (Describe resource and its major elements. Include design, materials, condition, alterations, size, setting, and boundaries.)
The one-story Storybook Ranch style building is generally 'L'-shaped in plan. The cross gabled roof, with boxed eaves, is clad in wood shingles. The roof crest is accented with a cupola. The westerly bay is accented with triangulated knee brackets. A brick chimney is centrally located on the western façade. The exterior walls are clad in vertical board and batten wood siding, accented horizontal wood siding, and smooth textured stucco. The diamond-paned sash and fixed-pane windows appear to be original. An attached two-car garage projects from the eastern end of the primary (northern) façade. The northern façade of the projecting garage is further accented with a diamond-paned fixed-pane window, and a half-height brick bay, with pent roof, partially spans the eastern end of the northern façade.

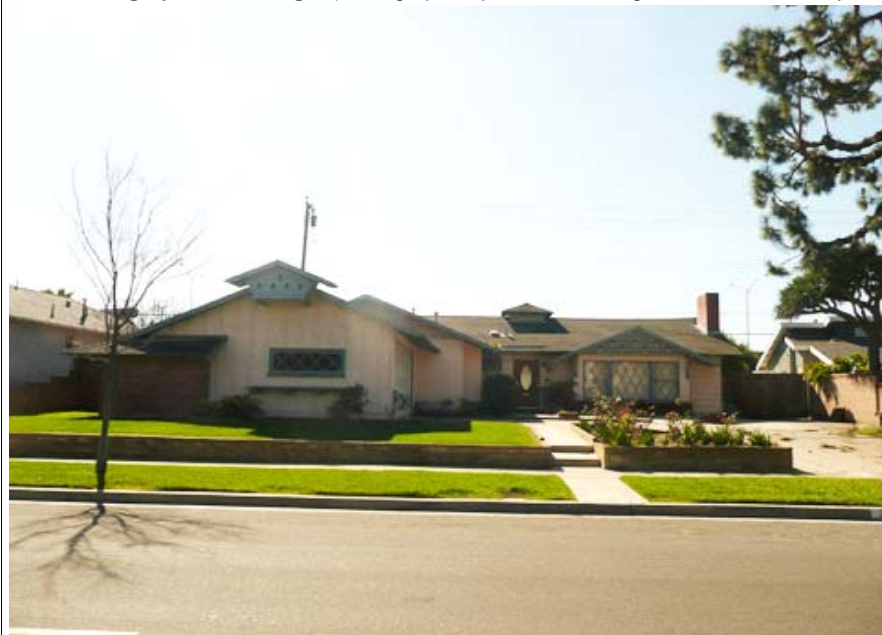
Facing south; 2/10/2010; Photo No.

* P3a. Description: (Describe resource and its major elements. Include design, materials, condition, alterations, size, setting, and boundaries.)
The one-story Storybook Ranch style building is generally 'L'-shaped in plan. The cross gabled roof, with boxed eaves, is clad in composition shingles. The roof crest is accented with a cupola, and the western and most northerly of the easterly gables of the primary (eastern) façade are accented with dovescotes. The westerly bay is further accented with triangulated knee brackets. A brick chimney is centrally located on the western façade. The exterior walls are clad in vertical board and batten wood siding, accented horizontal wood siding, and brick veneer. The diamond-paned sash and fixed-pane windows appear to be original. An attached two-car garage projects from the eastern end of the primary (northern) façade. The northern façade of the projecting garage is further accented with a diamond-paned fixed window with a window box, and a half-height brick bay, with pent roof, partially spans the southern end of the façade. The building does not meet the NRHP and CRHR eligibility criteria for the reasons identified on the district record prepared for this subdivision; therefore the building does not contribute to a historic district and is not individually eligible for listing in the NRHP and the CRHR.

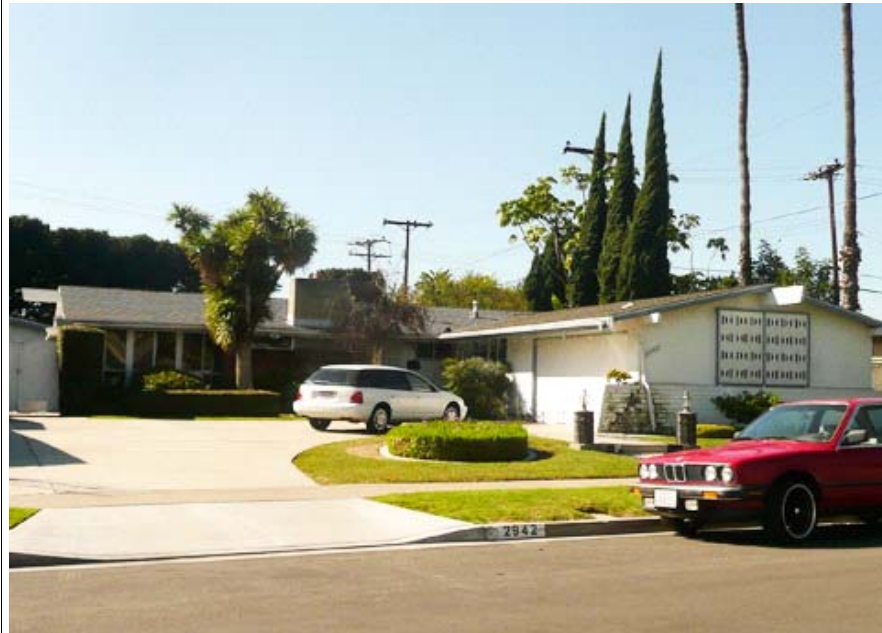
Facing south; 2/18/2010; Photo No.

* P3a. Description: (Describe resource and its major elements. Include design, materials, condition, alterations, size, setting, and boundaries.)
The one-story Ranch style building is 'L'-shaped in plan. The cross gabled roof, with boxed eaves, is clad in composition shingles. The gables are accented with false beams. The exterior walls are clad in smooth textured stucco. The projecting garage bay is accented with brick veneer to the water line, which extends to create a decorative battered wall, and screening panel. A large brick chimney accents the eastern bay of the primary (northern) façade. The aluminum sliding windows and glass doors appear to be original. The primary entrance is at grade and accessed via cast concrete porch. Landscaping includes mature yucca. The building does not meet the NRHP and CRHR eligibility criteria for the reasons identified on the district record prepared for this subdivision; therefore the building does not contribute to a historic district and is not individually eligible for listing in the NRHP and the CRHR.

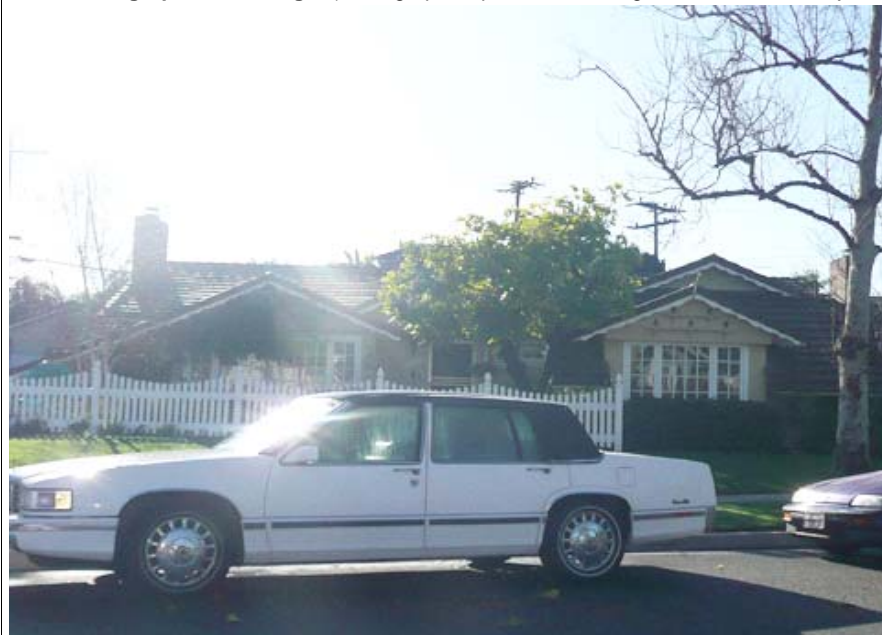
Facing southwest; 2/10/2010; Photo No.

* P3a. Description: (Describe resource and its major elements. Include design, materials, condition, alterations, size, setting, and boundaries.)
The one-story Storybook Ranch style building is generally 'L'-shaped in plan. The cross gabled roof, with boxed eaves, is clad in Spanish tile, which is an alteration. The roof crest is accented with a cupola, and the eastern and most northerly western gables of the primary (northern) façade are accented with doves. The easterly bay is further accented with triangulated knee brackets, and the asymmetrical gable roof extends beyond the building. A brick chimney is located on the eastern façade. The exterior walls are clad in coursed wood shingle siding and wavy-edge vertical siding. The wood sash, casement, and sliding windows appear to be original. The building does not meet the NRHP and CRHR eligibility criteria for the reasons identified on the district record prepared for this subdivision; therefore the building does not contribute to a historic district and is not individually eligible for listing in the NRHP and the CRHR.

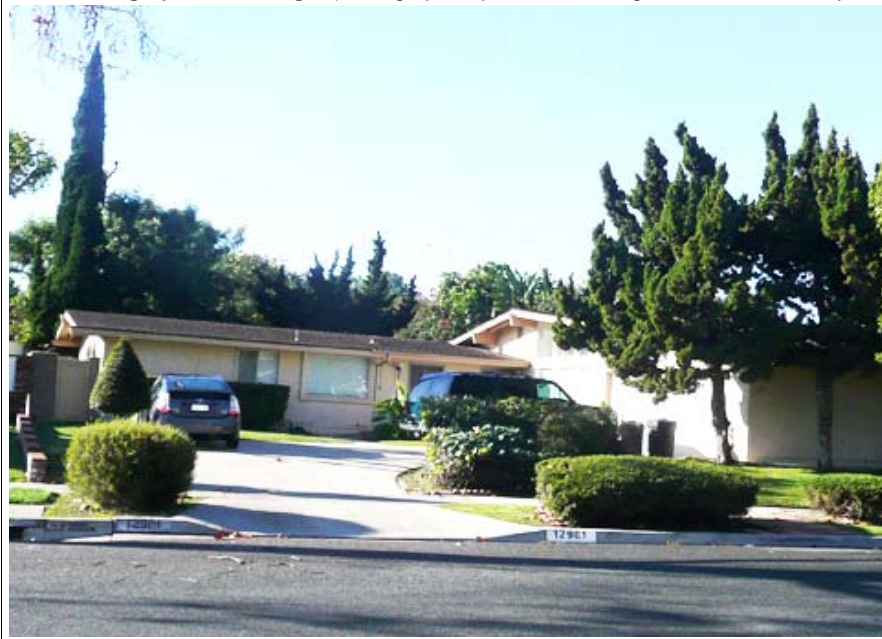
Facing south; 2/10/2010; Photo No.

* P3a. Description: (Describe resource and its major elements. Include design, materials, condition, alterations, size, setting, and boundaries.)
The one-story Ranch style building is 'L'-shaped in plan. The cross gabled roof, with boxed eaves and false beams, is clad in composition shingles. The exterior walls are clad in vertical wood siding and smooth textured stucco on the projecting bay on the west end of the primary (northern) facade. The metal casement and fixed-pane windows appear to be original. The primary entrance is raised and recessed. The projecting bay contains an attached two-car garage flanked by a ribbon of aluminum windows and a transom. Landscaping includes mature cedar bushes. The building does not meet the NRHP and CRHR eligibility criteria for the reasons identified on the district record prepared for this subdivision; therefore the building does not contribute to a historic district and is not individually eligible for listing in the NRHP and the CRHR.

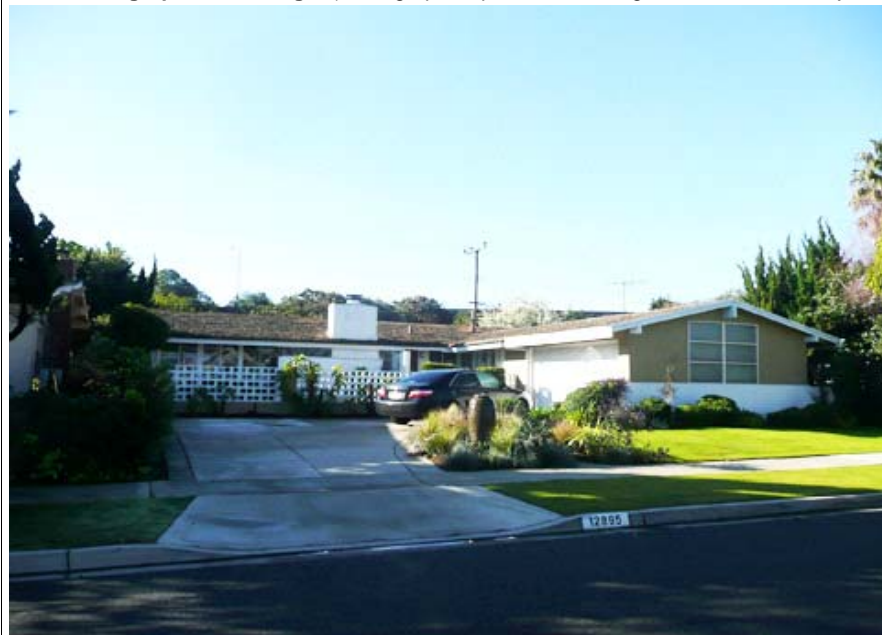
Facing south; 2/10/2010; Photo No.

* P3a. Description: (Describe resource and its major elements. Include design, materials, condition, alterations, size, setting, and boundaries.)
The one-story Ranch style building is 'L'-shaped in plan. The cross gabled roof, with boxed eaves and false beams, is clad in tar and pebbles. A brick chimney is prominently located on the eastern bay of the primary (northern) façade. The exterior walls are clad in smooth textured stucco with brick veneer to the water line on the northern face of the projecting garage, which extends beyond the building to create a battered wall. Metal fixed-pane and sliding aluminum windows open onto a central courtyard enclosed with a concrete screening block wall. A two-car garage projects from the eastern end of the primary (northern) façade, and is accented with a six-light fixed-pane pebble glass window. The building does not meet the NRHP and CRHR eligibility criteria for the reasons identified on the district record prepared for this subdivision; therefore the building does not contribute to a historic district and is not individually eligible for listing in the NRHP and the CRHR.

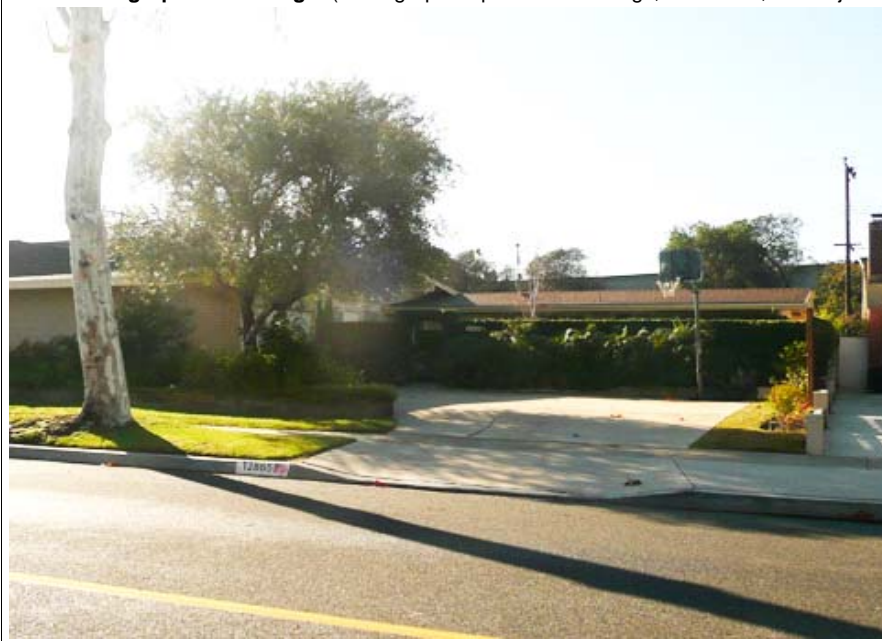
Facing south; 2/10/2010; Photo No.

* P3a. Description: (Describe resource and its major elements. Include design, materials, condition, alterations, size, setting, and boundaries.)
The one-story Ranch style building is 'L'-shaped in plan. The cross gabled roof, with false beams, is clad in composition shingles. The exterior walls are clad in smooth textured stucco, and the projecting eastern bay is also accented with brick veneer. The windows have been replaced with vinyl sliding and fixed pane units. A masonry wall clad in vegetation encloses a courtyard and provides access to the primary entrance. Other details not discernable from the public right of way. Landscaping includes a mature sycamore in parkway, and a mature olive tree. The building does not meet the NRHP and CRHR eligibility criteria for the reasons identified on the district record prepared for this subdivision; therefore the building does not contribute to a historic district and is not individually eligible for listing in the NRHP and the CRHR.

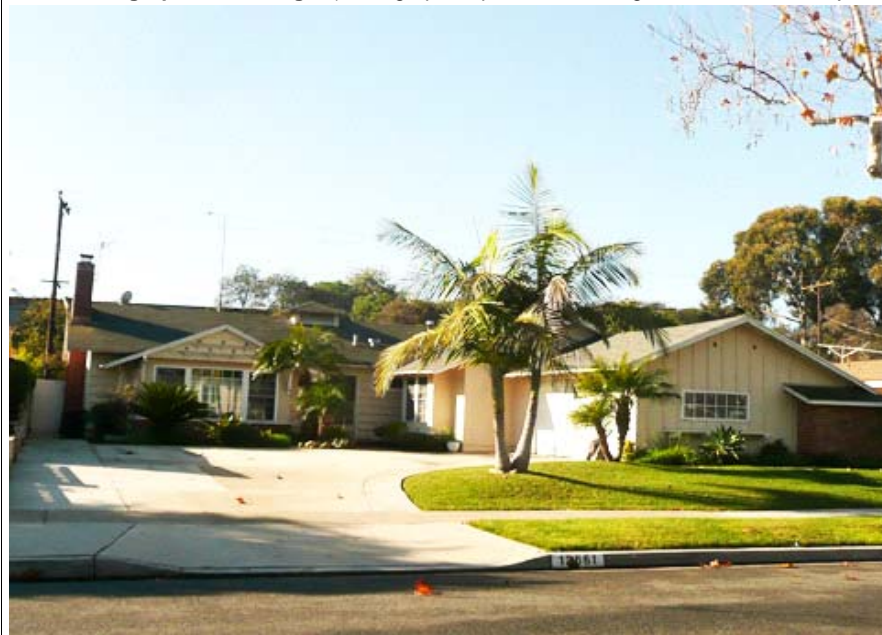
Facing south; 2/10/2010; Photo No.

* P3a. Description: (Describe resource and its major elements. Include design, materials, condition, alterations, size, setting, and boundaries.)
The one-story Storybook Ranch style building is generally 'L'-shaped in plan. The cross gabled roof, with boxed eaves, is clad in composition shingles. The roof crest is accented with a cupola, and the eastern and most northerly western gables of the primary (northern) façade are accented with dovescotes. The easterly bay is further accented with triangulated knee brackets and brick veneer to the water line. A brick chimney is located on the eastern façade. The exterior walls are clad in vertical board and batten wood siding, accented with wavy-edge wood siding and smooth textured stucco. The windows have been replaced with vinyl and fixed-pane units. An attached two-car garage projects from the western end of the primary (northern) façade. The northern façade of the projecting garage is further accented with a flowerbox ledge with corbels, and a half-height brick bay, with pent roof, partially spans the southern end of the façade. The building does not meet the NRHP and CRHR eligibility criteria for the reasons identified on the district record prepared for this subdivision; therefore the building does not contribute to a historic district and is not individually eligible for listing in the NRHP and the CRHR.

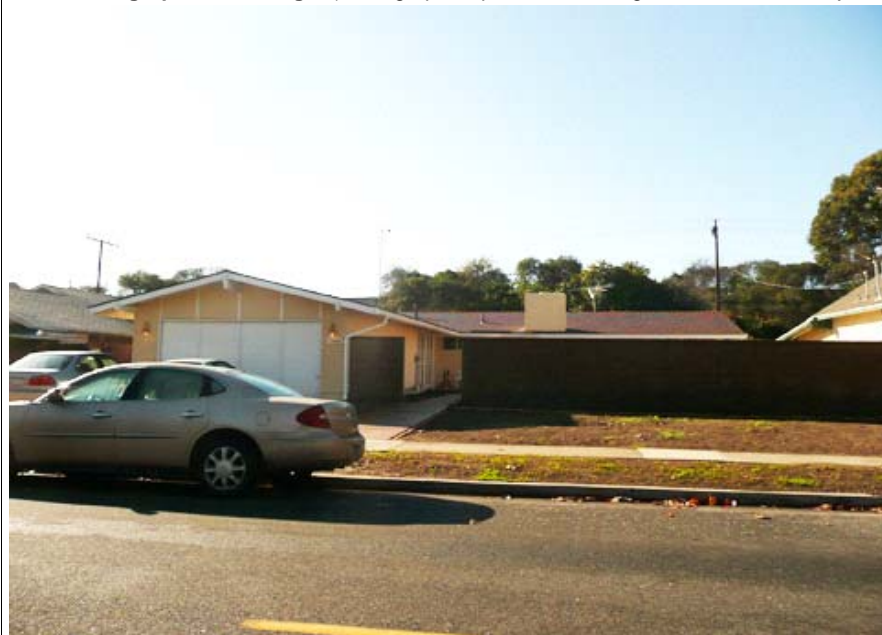
Facing south; 2/10/2010; Photo No.

* P3a. Description: (Describe resource and its major elements. Include design, materials, condition, alterations, size, setting, and boundaries.)
The one-story Ranch style building is 'L'-shaped in plan. The cross gabled roof is clad in composition shingles. A large concrete block chimney is prominently located on the western bay of the primary (northern) façade. The exterior walls are clad in smooth textured stucco, and the northern elevation of the project garage is accented with scored stucco and false timbering. The windows have been replaced with vinyl sash and fixed-pane units. The interior courtyard of the primary (northern) façade has been enlarge and enclosed with a modern concrete block wall with brick coping. The building does not meet the NRHP and CRHR eligibility criteria for the reasons identified on the district record prepared for this subdivision; therefore the building does not contribute to a historic district and is not individually eligible for listing in the NRHP and the CRHR.

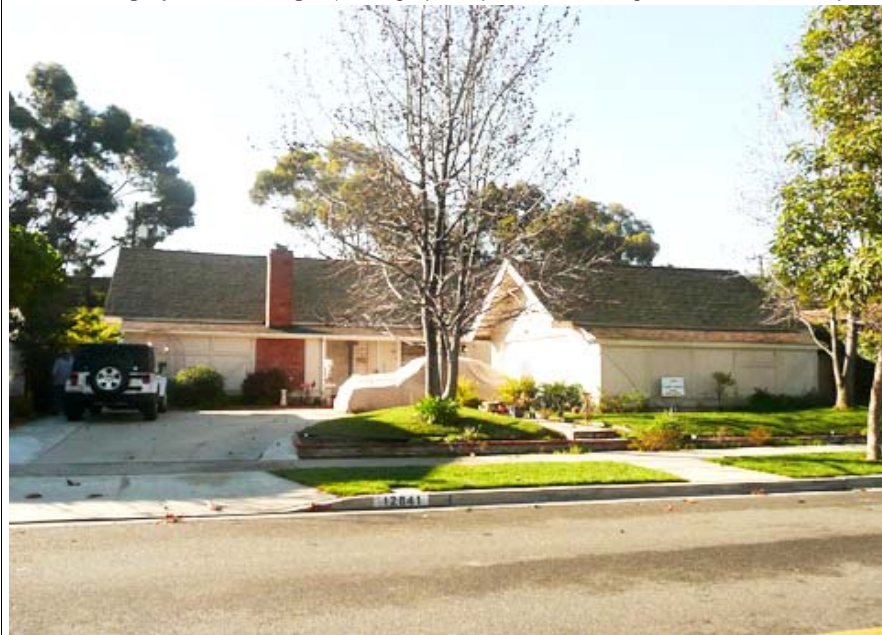
Facing south; 2/10/2010; Photo No.

* P3a. Description: (Describe resource and its major elements. Include design, materials, condition, alterations, size, setting, and boundaries.)
The one-story Ranch style building is rectangular in plan. The side gabled roof, with flared and boxed eaves, is clad in composition shingles. A brick chimney is located off-center on the primary (northern) façade. The exterior walls are clad in smooth textured stucco with false timbering. The multi-light wood casement windows appear to be original. The primary entrance is raised, and is accessed via a covered porch which spans the primary façade. Simple wood posts support the porch roof. A detached garage is located in the front of the parcel, and is of similar design and materials as the main building on the parcel.

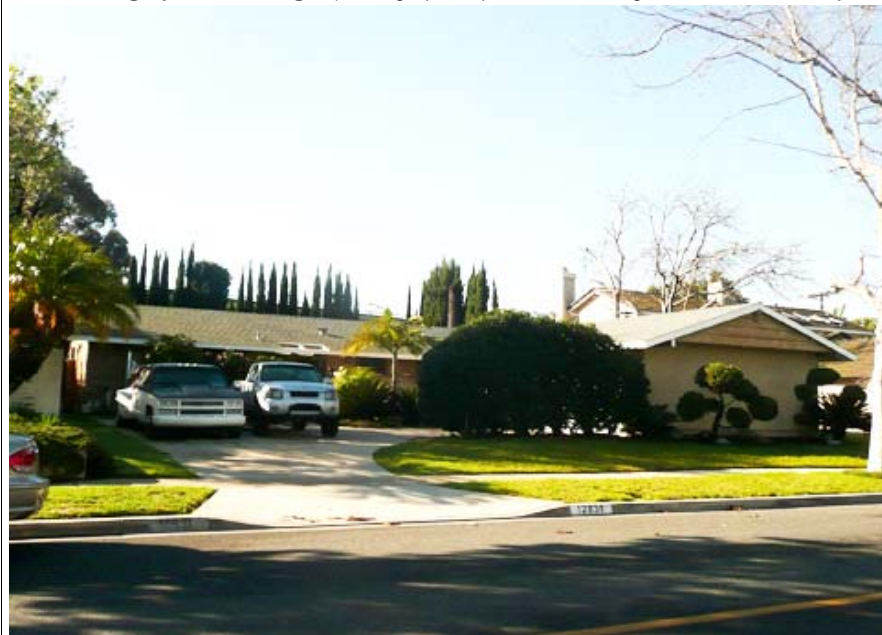
Facing the primary façade; 2/10/2010; Photo No. P1030812.jpg

* P3a. Description: (Describe resource and its major elements. Include design, materials, condition, alterations, size, setting, and boundaries.)
The one-story Ranch style building is 'L'-shaped in plan. The cross gabled roof, with decorative light openings in the overhanging eaves and false beams, is clad in composition shingles. The exterior walls are clad in smooth textured stucco, with wavy-edge vertical wood siding and horizontal siding in the gables. A brick wall encloses the primary entryway. An attached two-car garage projects from the northern end of the primary (eastern) façade. Other details are obscured by vegetation. The building does not meet the NRHP and CRHR eligibility criteria for the reasons identified on the district record prepared for this subdivision; therefore the building does not contribute to a historic district and is not individually eligible for listing in the NRHP and the CRHR.

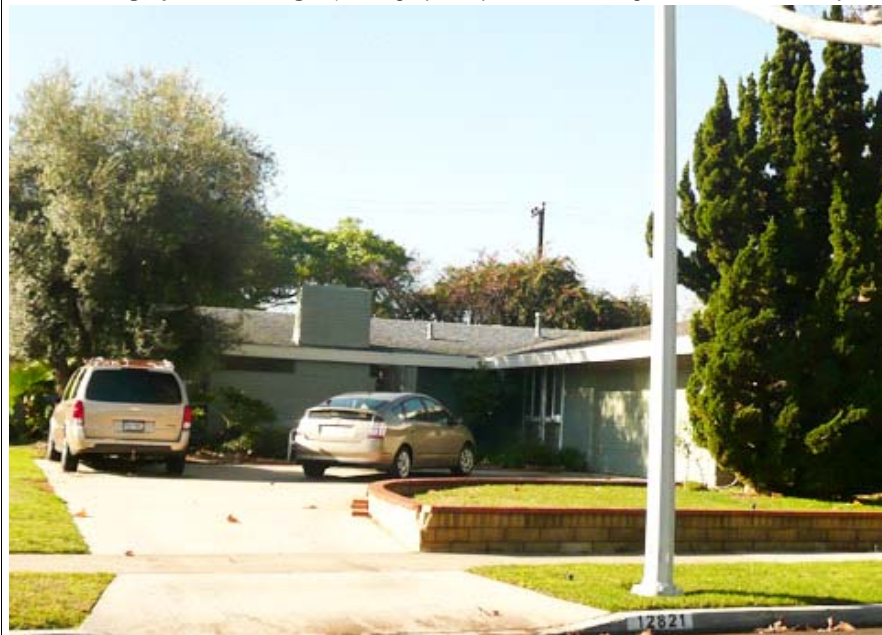
P5b. Description of Photo: (View, date, etc.)
Facing the primary façade; 2/10/2010; Photo No. P1030813.jpg

* P3a. Description: (Describe resource and its major elements. Include design, materials, condition, alterations, size, setting, and boundaries.)
The one-story Ranch style building is 'L'-shaped in plan. The cross gabled roof is clad in composition shingles. A brick chimney is centrally and prominently located on the southern bay of the primary (eastern) façade. The windows have been replaced with vinyl sliding and fixed-pane units. The primary entrance is recessed, and a brick wall partially separates the entryway from the courtyard area. An attached two-car garage projects from the northern end of the primary (eastern) façade. Landscaping includes a mature sycamore in the parkway, mature cedar and olive trees, and concrete block with brick retaining walls. The building does not meet the NRHP and CRHR eligibility criteria for the reasons identified on the district record prepared for this subdivision; therefore the building does not contribute to a historic district and is not individually eligible for listing in the NRHP and the CRHR.

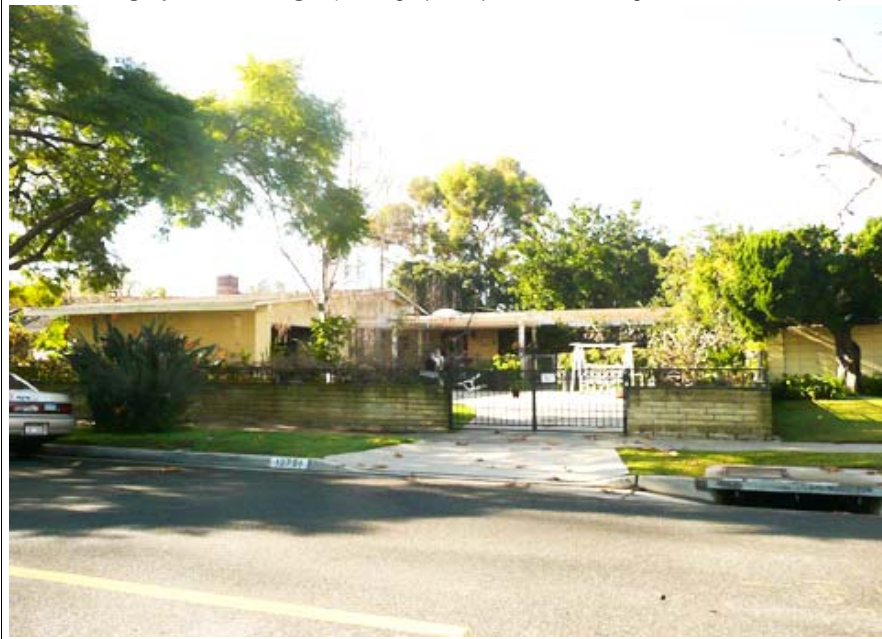
Facing southwest; 2/10/2010; Photo No.

* P3a. Description: (Describe resource and its major elements. Include design, materials, condition, alterations, size, setting, and boundaries.)
The one-story Ranch style building is 'L'-shaped in plan. The cross gabled roof, with boxed eaves and false beams, is clad in composition shingles. It is not known if the bubble skylight is original. A brick chimney is centrally located on the southern bay of the primary façade. The exterior walls are clad in smooth textured and scored stucco. Aluminum fixed-pane and casement windows open onto the courtyard, and remaining windows appear to be aluminum fixed-pane units. A concrete block and metal fence creates a central courtyard through which the primary entrance is accessed. The projecting bay contains a two-car garage.
